## USS STARK (FFG-31) AFFAIR

**USS STARK (FFG-31)**  
**PERSIAN GULF OPERATIONS**  
**17 MAY 1987**

THIS AFTERNOON I WILL BRIEF YOU ON THE FINDINGS OF A FFG 7 PANEL CONVENED BY THE SECRETARY OF THE NAVY TO ANALYZE THE "TECHNICAL ASPECTS" OF THE STARK INCIDENT. THE STORY OF STARK IS ONE THAT WILL REVEAL A TOUGH SHIP, A DETERMINED AND HEROIC CREW AND A NAVY APPROACH TO SURVIVABILITY.

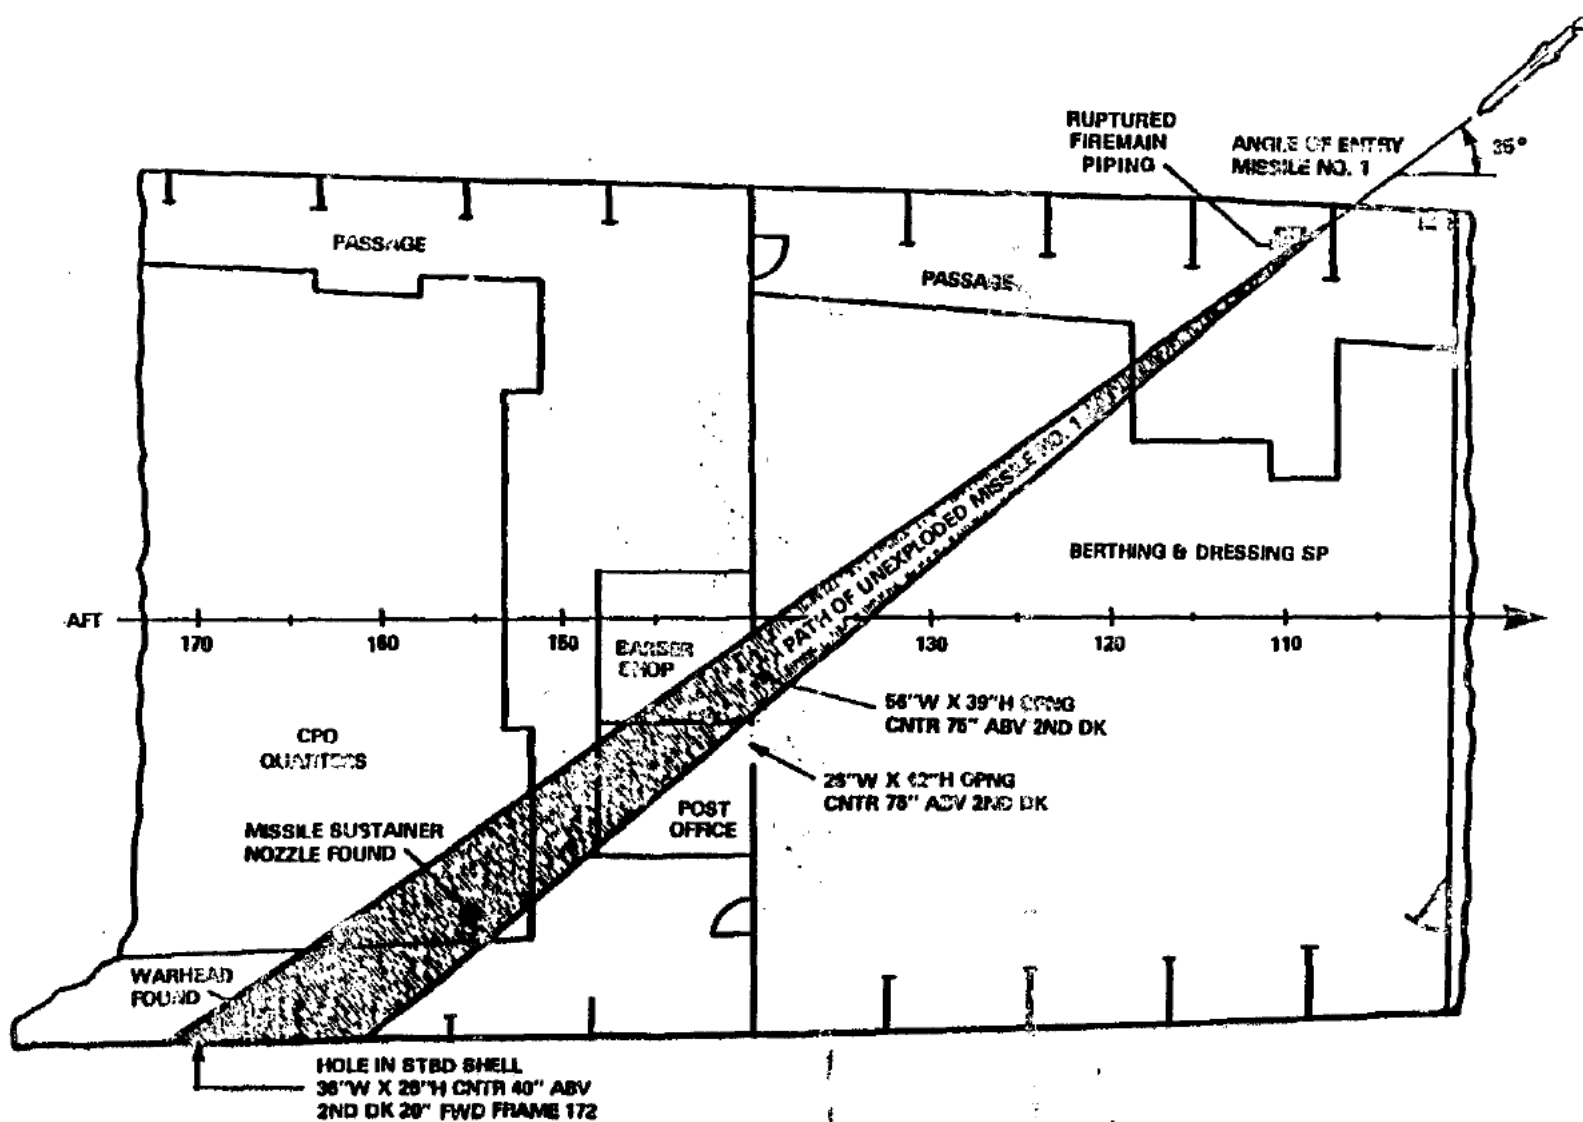
# MISSILE NO. 1 SECOND DECK IMPACT

AT ABOUT 9:12 PM ON 17 MAY 1987, THE FIRST OF TWO EXOCET MISSILES HIT THE PORT SIDE OF THE SHIP APPROXIMATELY 13 FEET ABOVE THE WATER LINE, UNDER THE PORT BRIDGE WING. WITH AN IMPACT ANGLE OF ABOUT 35 DEGREES OFF THE BOW AND A SPEED OF NEARLY 600 MPH, THE MISSILE SEVERED FIREFIGHTING WATER PIPES SUPPLYING THE FORWARD PART OF THE SHIP, SEPARATED INTO TWO LARGE PIECES, BUT FAILED TO DETONATE. THE TWO PARTS, THE AIRFRAME AND THE WARHEAD, PASSED THROUGH ONE OF THE CREW'S SLEEPING QUARTERS AND CONTINUED DIAGONALLY ACROSS THE DECK SPREADING NEARLY 120 POUNDS OF BURNING RESIDUAL SOLID PROPELLANT IN THEIR WAKES. THE UNEXPLODED WARHEAD CAME TO REST AGAINST THE STARBOARD HULL PLATING.

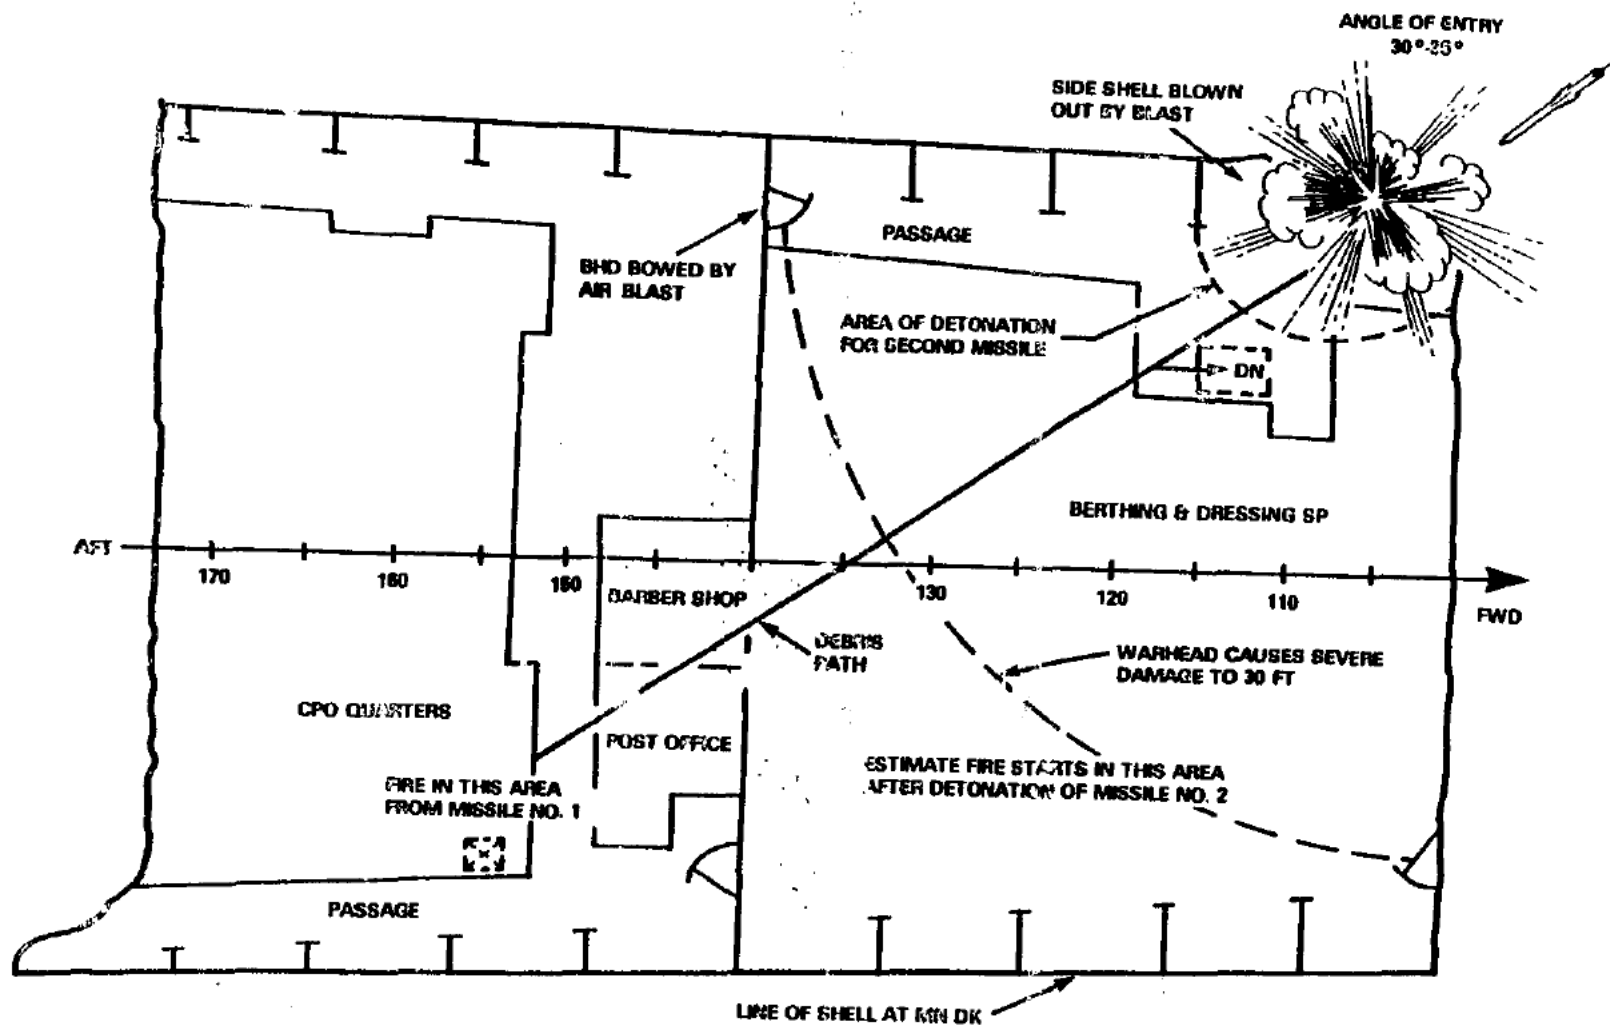
# MISSILE NO. 2 SECOND DECK IMPACT

20 TO 30 SECONDS AFTER THE FIRST HIT, THE SECOND MISSILE, APPROACHING FROM THE SAME ANGLE OFF THE BOW, IMPACTED THE SHIP APPROXIMATELY 8 FEET AFT OF THE FIRST MISSILE'S POINT OF ENTRY. THIS TIME, THE WARHEAD DETONATED 5 FEET INSIDE THE HULL. THE RESIDUAL PROPELLANT FROM BOTH MISSILES COMBINED WITH THE HEAT OF DETONATION AND A CONTINUOUS OXYGEN SUPPLY TO CREATE AN IMMEDIATE INFERNO IN THE SECOND DECK BERTHING COMPARTMENT.

- 0 EXTERNALLY, IT CREATED A GAPING HOLE IN THE HULL AND DAMAGED THE BRIDGE WING, BULWARK AND MAIN DECK SUPERSTRUCTURE AREAS ON THE PORT SIDE, ALLOWING FREE AIR VENTILATION FOR COMBUSTION AND RESTRICTING FIRE TEAM ACCESS;
- 0 INTERNALLY, THE WARHEAD DETONATION DESTROYED THREE PRIMARY, FIREFIGHTING WATER MAIN, ISOLATION VALVES AND DAMAGED SEVERAL WATERTIGHT DOORS THAT WERE NEEDED TO LIMIT THE SPREAD OF SMOKE AND FIRE; AND,
- 0 THE THERMAL PULSE SUPPLIED INSTANTANEOUS HEAT TO THE BERTHING COMPLEX AND THE SECOND MISSILE INTRODUCED MORE BURNING PROPELLANT INTO THE SPACE

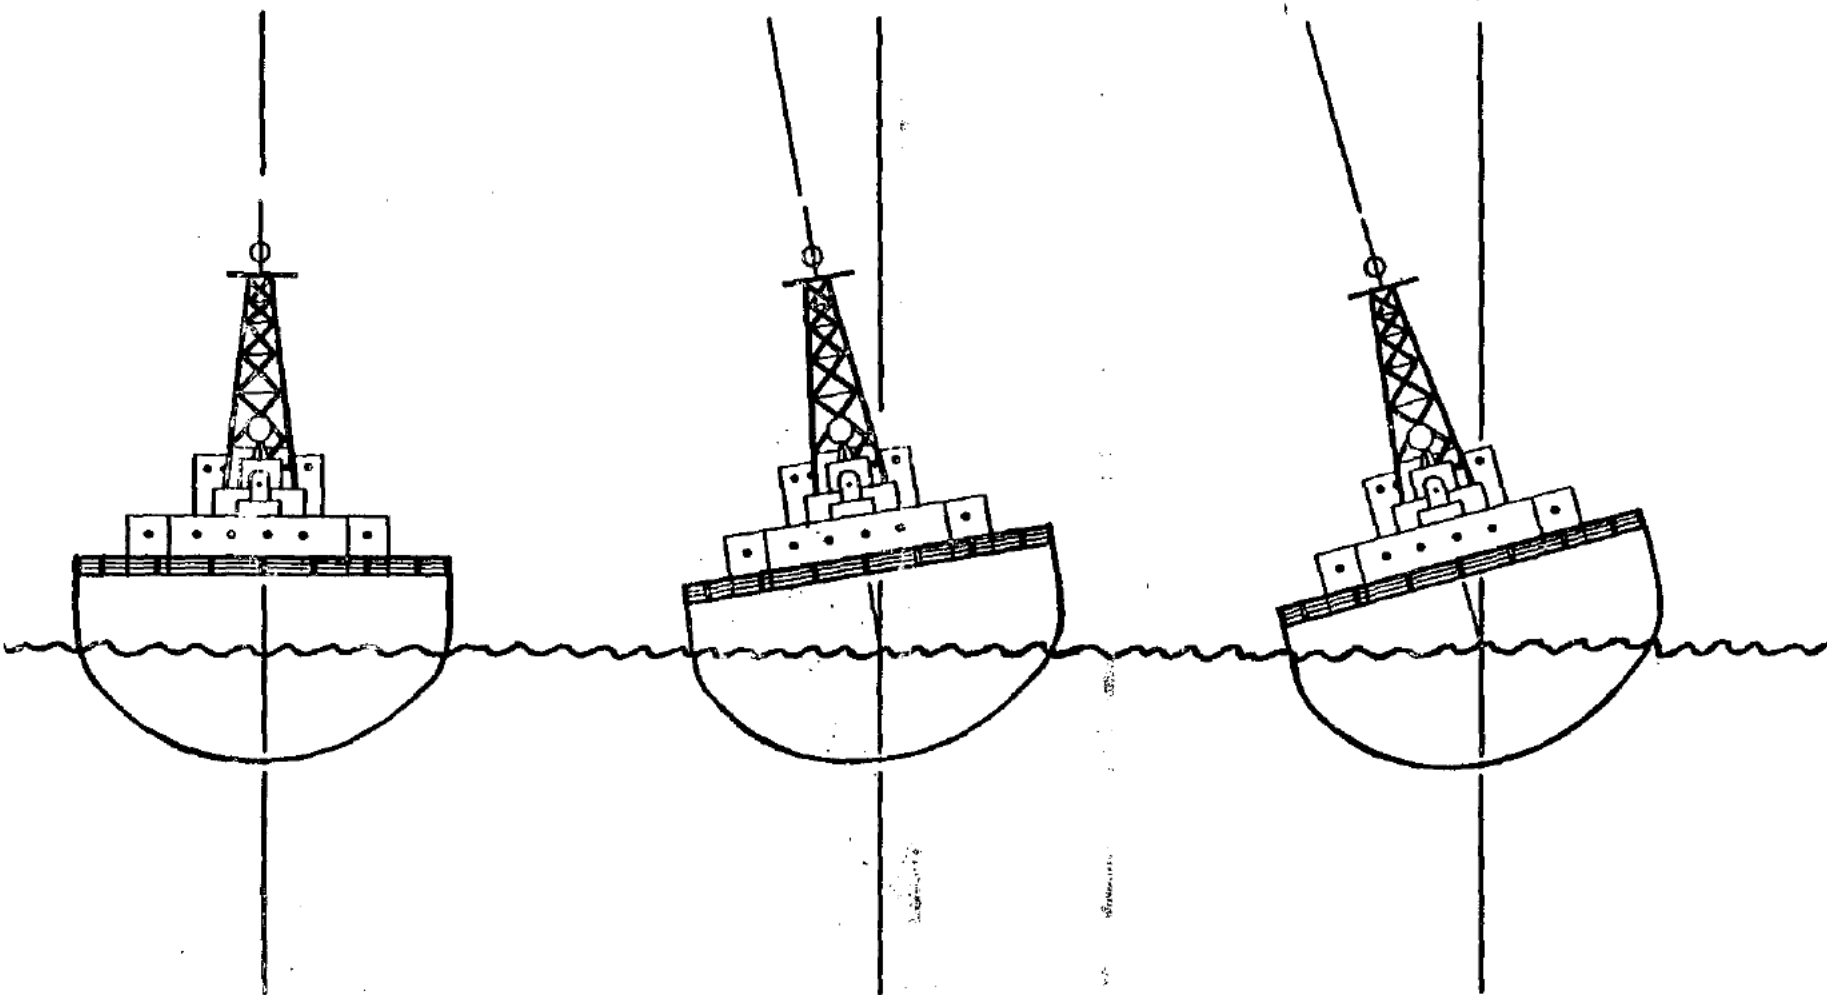
WITHIN 15 MINUTES, THE SHIP WAS LISTING 11.5 DEGREES TO PORT AS A RESULT OF WATER FLOWING FROM THE RUPTURED FIREMAIN, WHICH HAD YET TO BE ISOLATED.

BY 9:50, THE SHIP WAS LISTING 16 DEGREES AS A RESULT OF THE WATER FROM THE NOW ISOLATED FIREMAIN RUPTURE, AS WELL AS THE WATER BEING USED TO FIGHT THE FIRE. CREW MOVEMENT BECAME EXTREMELY DIFFICULT. THE FIRE CONTINUED TO SPREAD AFT, THROUGHOUT THE CHIEF PETTY OFFICER'S QUARTERS.

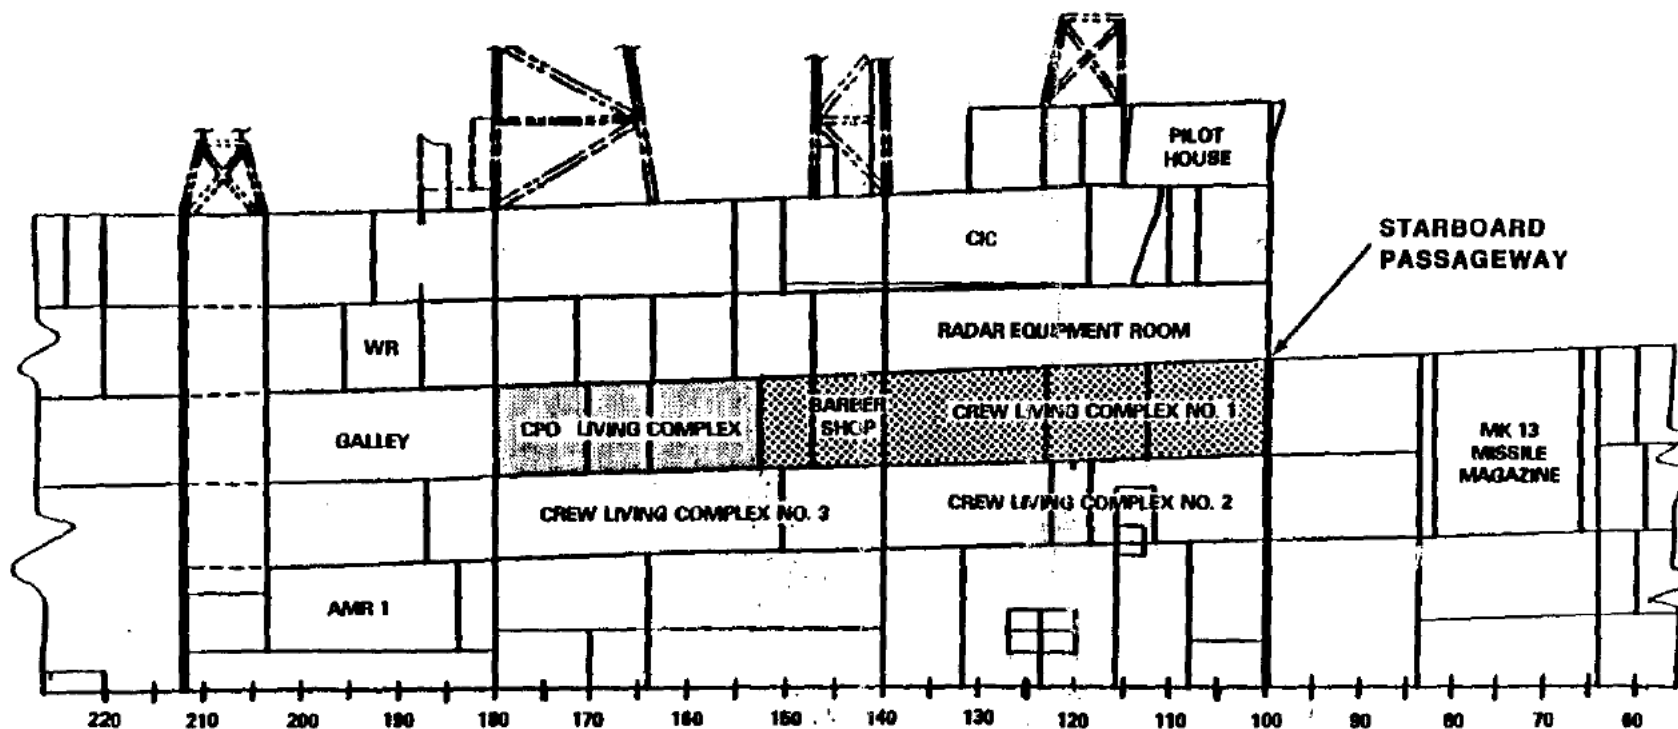
BY 9:30, THE COMBAT INFORMATION CENTER, TWO DECKS ABOVE, WAS ALREADY PARTIALLY FILLED WITH SMOKE AND THE MISSILE MAGAZINE HAD TO BE COOLED WITH FIREFIGHTING WATER.

AS A RESULT OF THE RUPTURED FIREMAIN, THE ONLY MEANS OF SUPPLYING FIREFIGHTING WATER TO THE FORWARD MAIN DECK AREA AND THE MISSILE MAGAZINE WAS THROUGH THE USE OF A PORTABLE, GAS-DRIVEN PUMP, OR NAVY P-250.

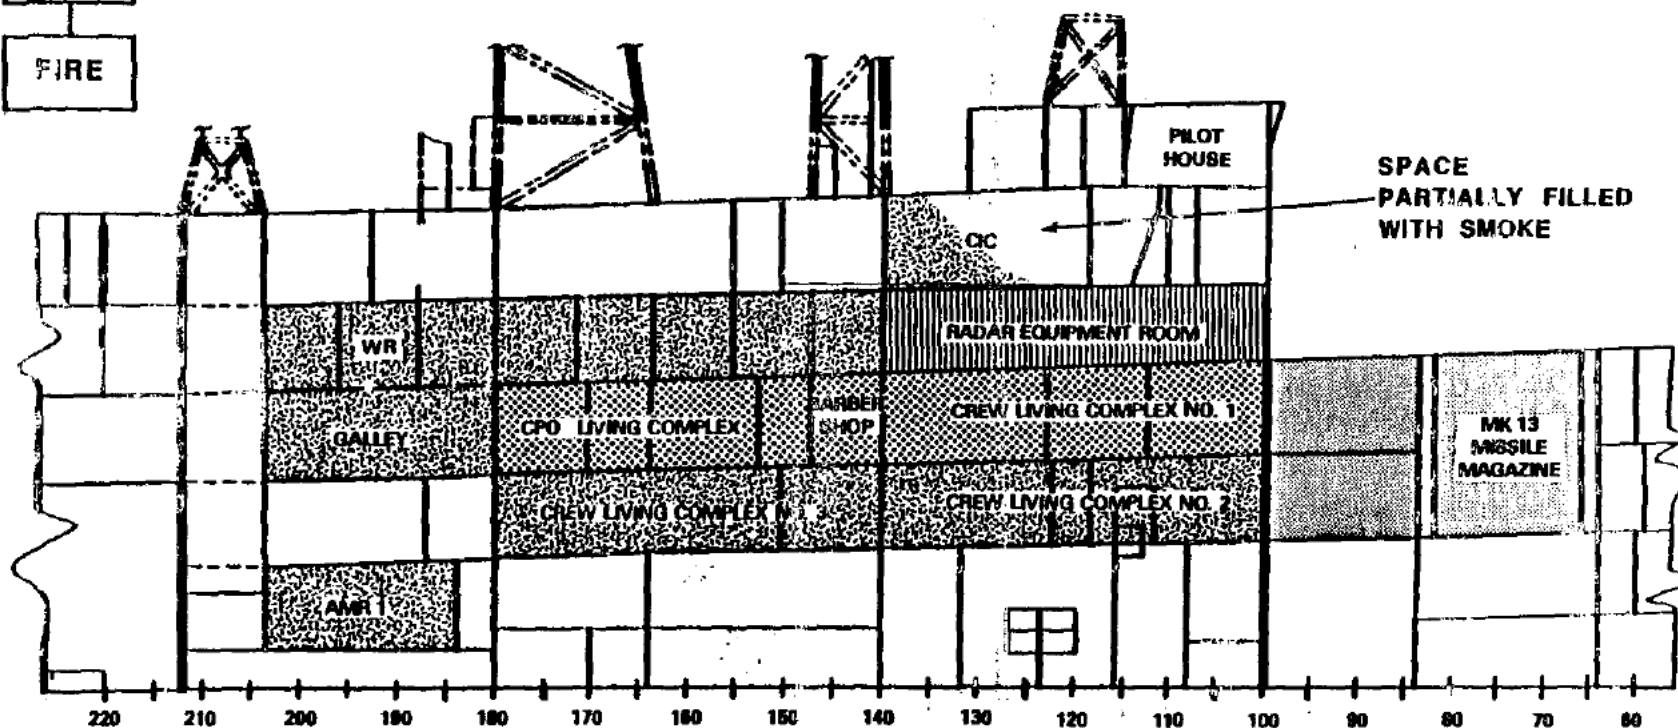
BY 9:38, THE RUPTURE IN THE FIREMAIN HAD BEEN ISOLATED AT THE NEXT MOST ACCESSIBLE VALVE, RESULTING IN NO WATER FORWARD OF FRAME 180, AS SHOWN, BUT FULL FIREFIGHTING WATER PRESSURE WAS RESTORED TO THE REMAINDER OF THE SHIP.

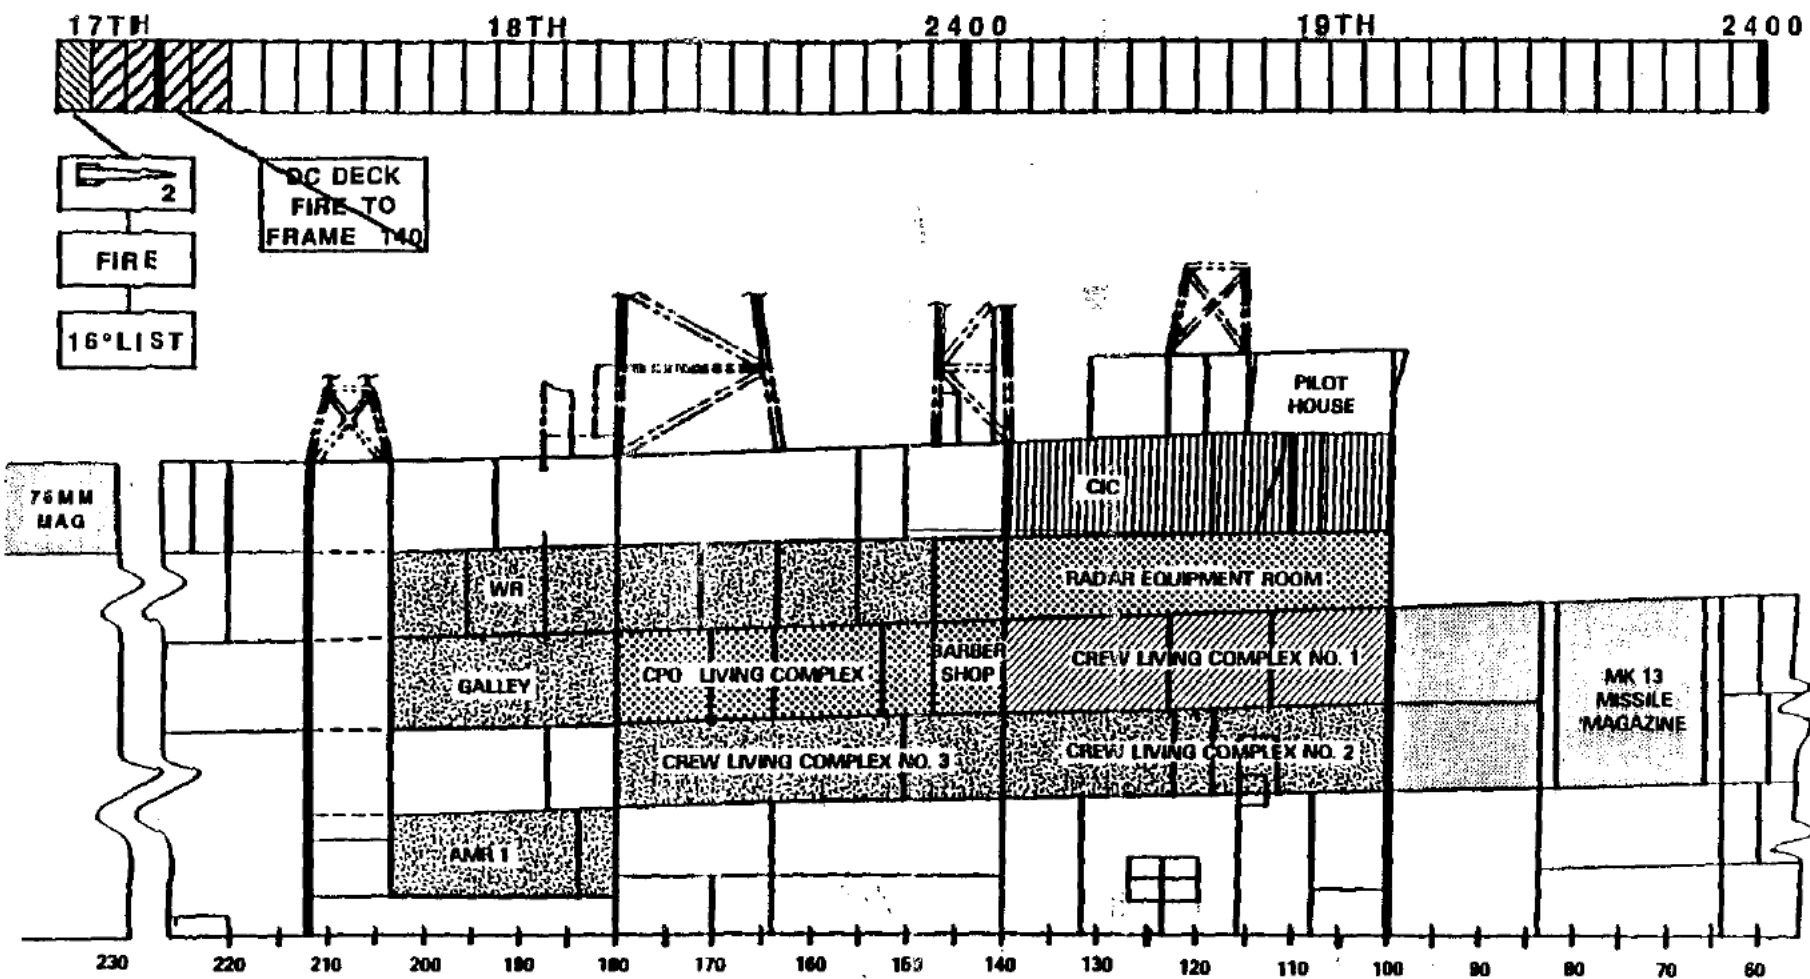
AT 11 O'CLOCK, THE REPORT OF A FIRE IN THE RADAR EQUIPMENT ROOM INDICATED THAT THE FIRE WAS SPREADING VERTICALLY. THIS DEVELOPMENT WAS CAUSED BY AN "OVEN EFFECT", OR THE CONDUCTION OF HEAT THROUGH THE OVERHEAD TO THE SPACE ABOVE. HORIZONTAL SPREAD OF THE FIRE WAS EFFECTIVELY BROUGHT UNDER CONTROL.

AT 0900, THE VERTICAL FIRE SPREAD CONTINUED AS EVIDENCED BY THE LOSS OF STRUCTURAL STRENGTH AND THE FAILURE OF THE OVERHEAD IN THE RADAR EQUIPMENT ROOM AND THE COLLAPSE OF THE DECK IN THE CAPTAIN'S CABIN. BY 10 AM ON THE 18TH THE FIRE WAS CONFINED TO THE RADAR EQUIPMENT ROOM AND THE COMBAT INFORMATION CENTER.
